Mountains to Sound Home Inspection

Building Inspection Report

Client(s): Cal Spangler
Property address: **Shoreline Unitarian Universalist Church**
14724 1st Ave NE
Shoreline WA 98155-6806

Inspection date: Thursday, February 27, 2014

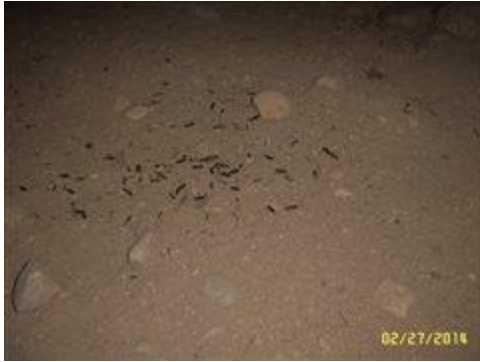
Photo 1-1

Evidence of rodent infestation was found in the form of feces in the attic and crawl space. Consult with the property owner about this. A qualified person should make repairs to seal openings in the structure, set traps, and clean rodent waste as necessary. Recommend following guidelines in these Center for Disease Control articles:

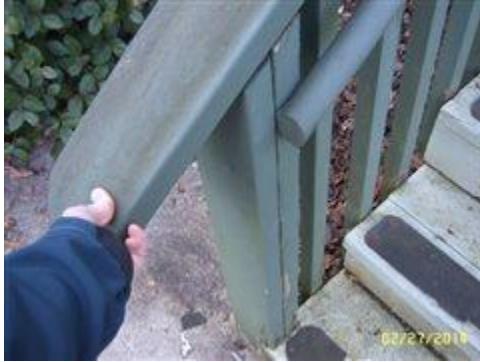
Photo 3-1

- 3) 🚧 Handrails at one or more flights of stairs were wobbly. This is a safety hazard. Recommend that a qualified person repair as necessary.

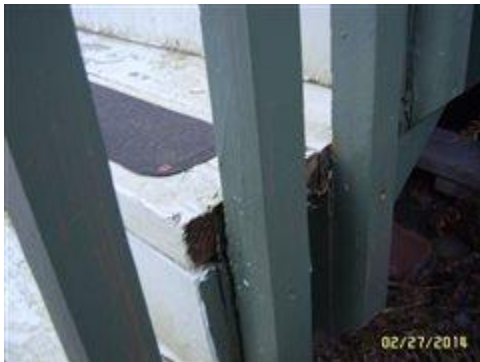
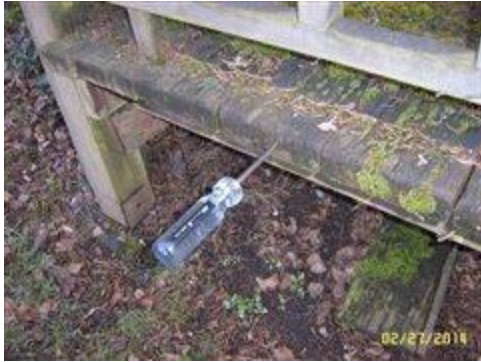
- 4) 🔍 Fungal rot was found in decking boards at one or more decks or porches. Conductive conditions for this such as wood-soil contact should be corrected. Recommend that a qualified contractor evaluate and repair as necessary. All rotten wood should be replaced.

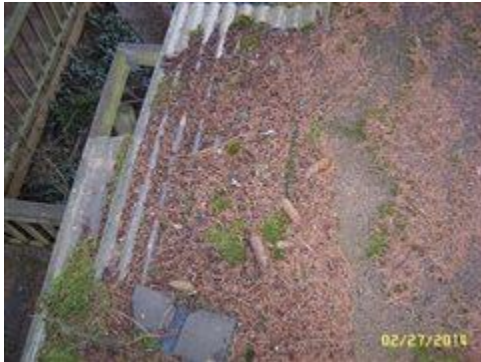
Photo 5-1

One or more deck, patio and/or porch covers were deteriorated or substandard. Recommend that a qualified person repair or replace as necessary, and per standard building practices.

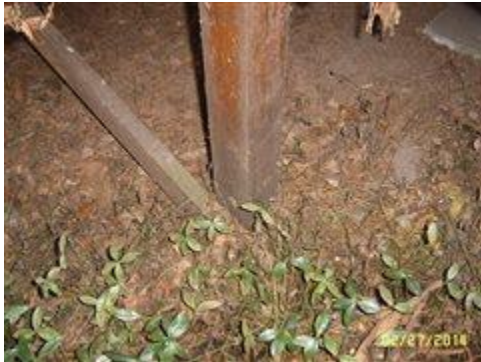
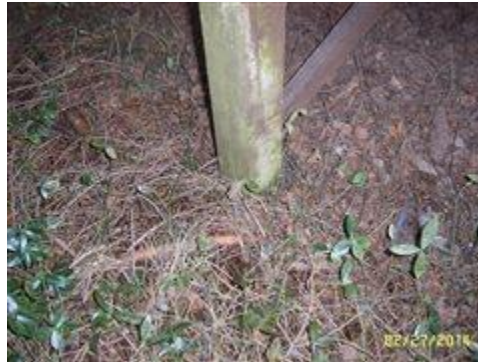
Soil was in contact with or too close to wooden deck or porch substructure components. This is a conducive condition for wood-destroying organisms. Clearances to soil should be as follows:

Pressure treated wood is typically rated for 25 year contact with soil, but the cut ends hidden below grade may not have been treated and can rot quickly. Support posts should be elevated above grade on concrete piers or footings, and be separated from the concrete by metal brackets or an impermeable membrane such as shingle scraps. For other components, soil should be graded and/or removed to maintain these clearances if possible. Otherwise, replacing non-treated wood with treated wood, or installing borate-based products such as Impel rods may help to prevent infestation and damage. For more information, visit:

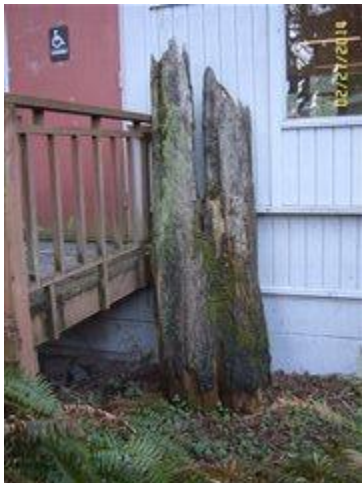
Photo 9-1

One or more large tree stumps were close to the building exterior. Wood-destroying insects such as carpenter ants nest in such stumps and are more likely to infest the building as a result. Recommend that large tree stumps within a few feet of the building be removed by a qualified tree service contractor.

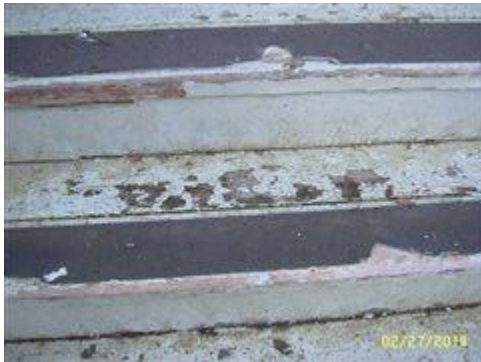
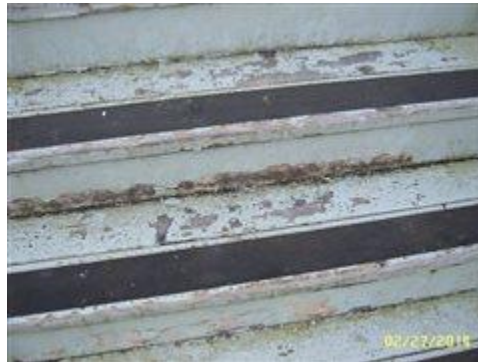
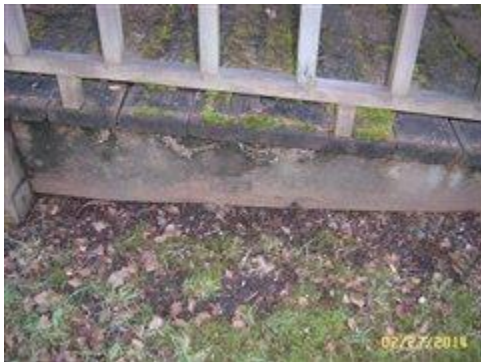
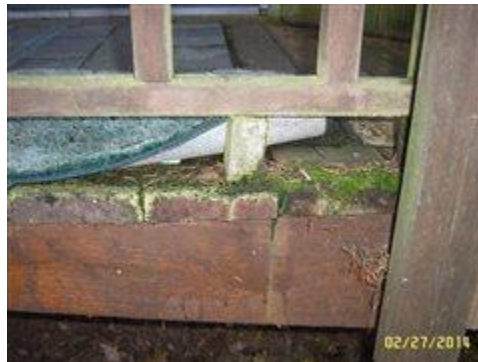
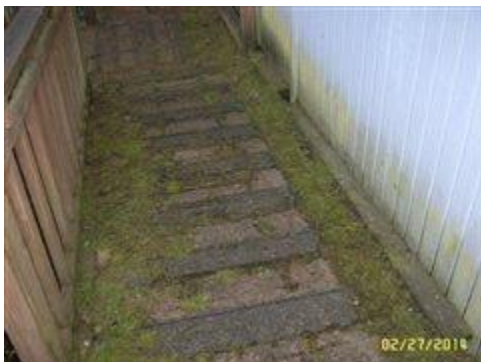
Wooden deck or porch surfaces, railings were overdue for normal maintenance. Recommend that a qualified person clean and preserve as necessary. Where decks have been coated with a finish such as opaque stains or paint, it may be too difficult to strip the finish and apply anything but paint or opaque stain. Where transparent stain or penetrating oil has been applied in the past, recommend that a penetrating oil be used. For more information, visit: <http://www.reporthost.com/?PENOIL>
<http://www.reporthost.com/?DKMAIN>

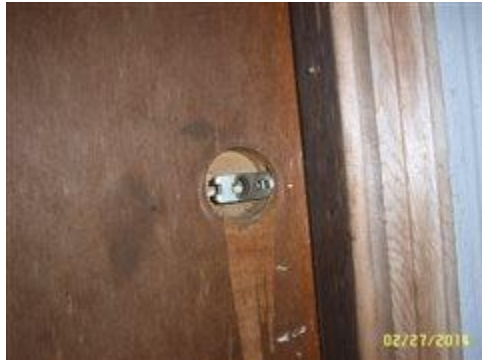
Photo 11-1

11) One or more abandoned exterior doors have not been properly removed resulting in vulnerability to water intrusion and poor insulation. Recommend a qualified contractor evaluate and repair.

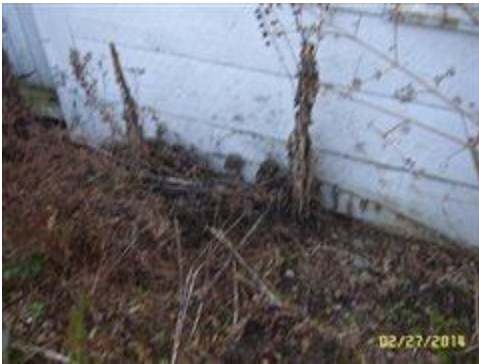
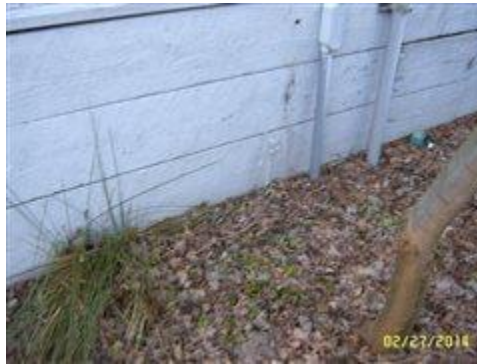
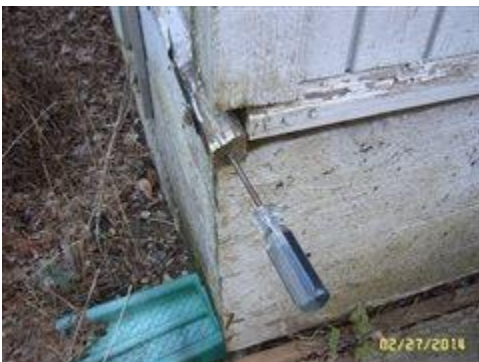
Soil was in contact with or less than 6 inches from siding, trim or structural wood. This is a conducive condition for wood-destroying organisms. Recommend grading or removing soil as necessary to maintain a 6-inch clearance. If not possible, then recommend replacing untreated wood with pressure-treated wood. Installation of borate-based products such as Impel rods can also reduce the likelihood of rot or infestation if soil cannot be removed. Note that damage from fungal rot and/or insects may be found when soil is removed, and repairs may be necessary.

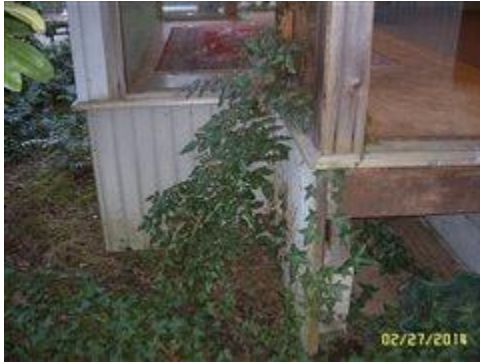
Photo 15-1

Vegetation such as trees, shrubs and/or vines was in contact with or close to the building exterior. Vegetation can serve as a pathway for wood-destroying insects and can retain moisture against the exterior after it rains. This is a conducive condition for wood-destroying organisms.

Recommend pruning, moving or removing vegetation as necessary to maintain at least 6 inches of space between it and the building exterior. A 1-foot clearance is better.

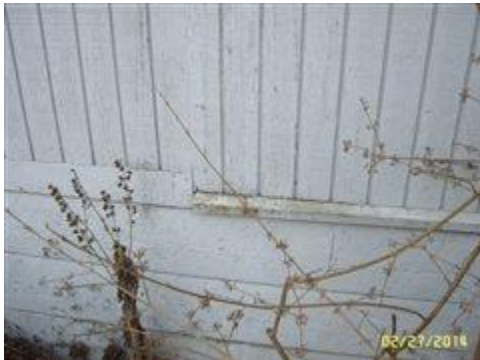
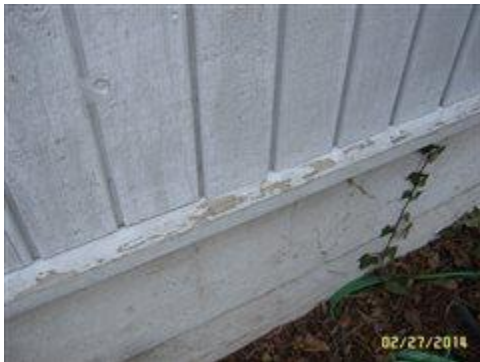
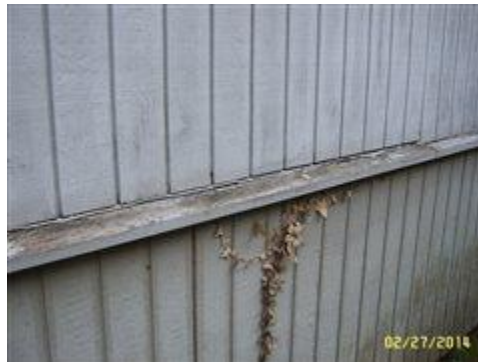
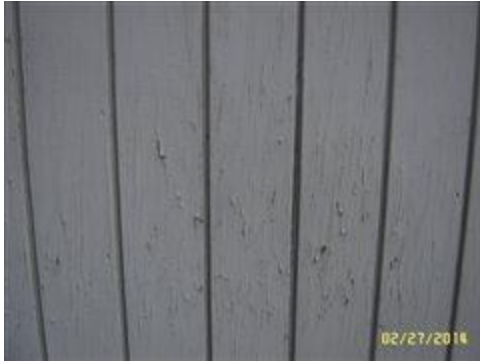
The paint or stain finish in some areas was failing (e.g. peeling, faded, worn, thinning). Siding and trim with a failing finish can be damaged by moisture. Recommend that a qualified contractor prep (e.g. clean, scrape, sand, prime, caulk) and repaint or restain the building exterior where necessary and per standard building practices. Any repairs needed to the siding or trim should be made prior to painting or staining.

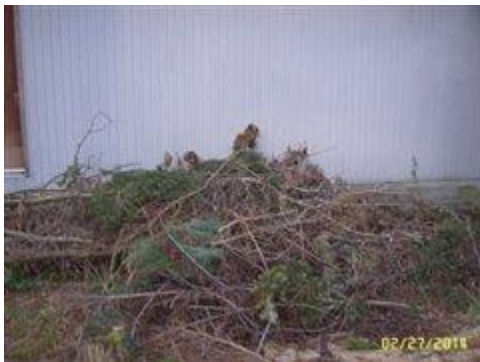
Photo 17-1

17) **i** Firewood, logs, and branches were stored so that it was in contact with or close to the building exterior. This is a conducive condition for wood-destroying organisms. Recommend storing these items outdoors in an open area, and as far away from buildings as practical to keep insects away from buildings. For more information visit:

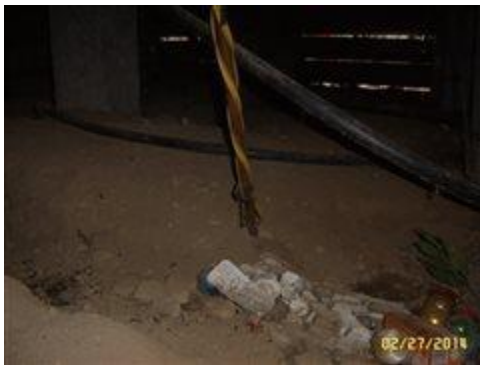
Photo 18-1

No vapor barrier was installed in the crawl space. This is a conducive condition for wood-destroying organisms due to the likelihood of water evaporating from the soil below up into the structure. A 6 mil black plastic sheet should be placed over all exposed soil with seams overlapped to 24 inches, and not in contact with any wood structural components. The sheeting should be held in place with bricks or stones, not wood. Recommend that a qualified contractor install a vapor barrier per standard building practices.

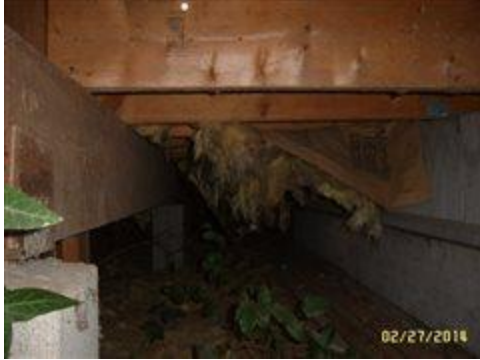
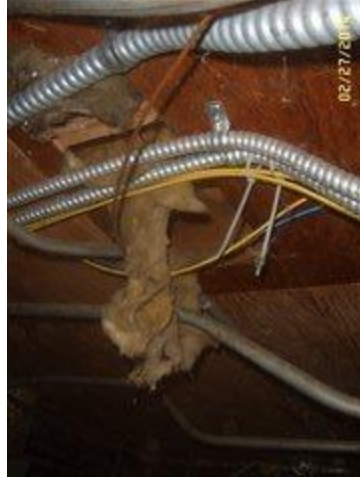
Some sections of under-floor insulation above the crawl space have fallen down. This may result in reduced energy efficiency. Recommend that a qualified person install or replace insulation as necessary.

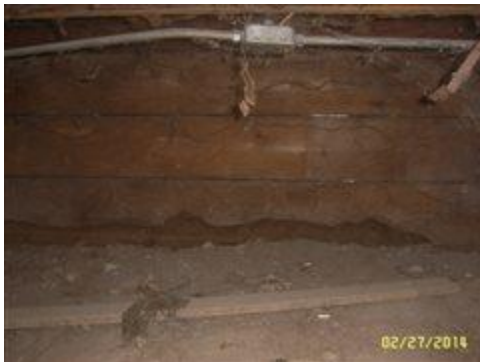
Photo 20-1

20) Past water intrusion visible in crawlspace where porch is located. Recommend a qualified person evaluate and repair as necessary.

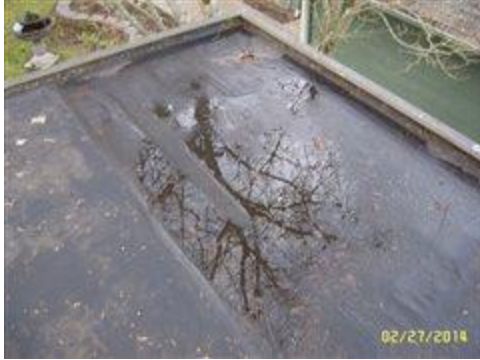
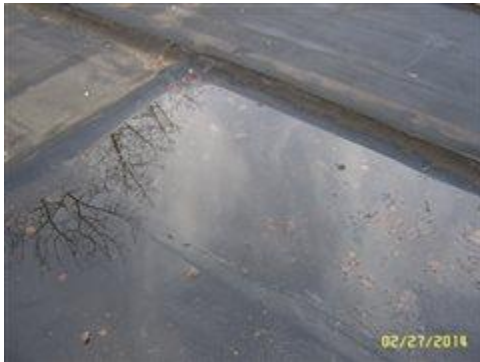
Ponding (pools of standing water) was found at one or more locations on the flat or low-slope roof surface. Even on a flat roof, water should be removed by a drainage system so that any remaining water evaporates within 48 hours after it rains. Prolonged standing water can result in roof leaks. This is a conducive condition for wood-destroying organisms. Recommend that a qualified contractor evaluate and repair as necessary to prevent ponding.

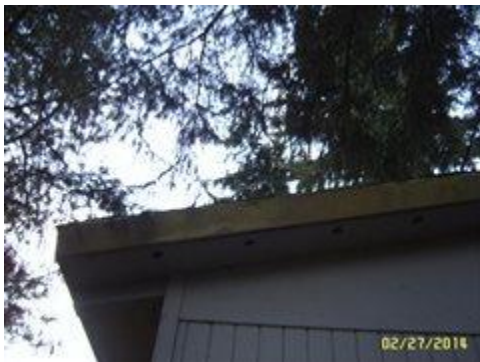
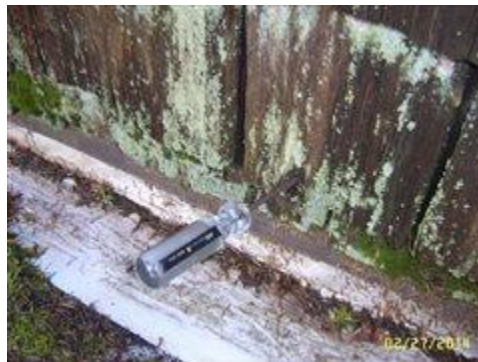
24) 🛠️ Fungal rot or significant water damage was found at one or more roof areas at fascia boards. Recommend that a qualified contractor repair as necessary. For example, by replacing all rotten wood, priming and painting new wood and installing flashing.

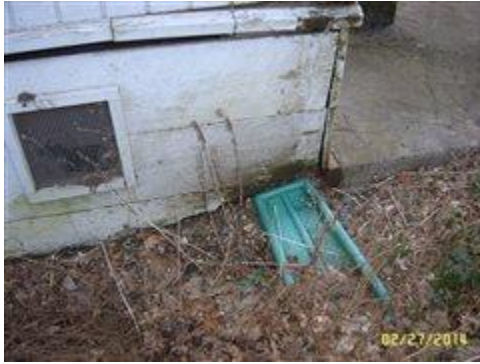
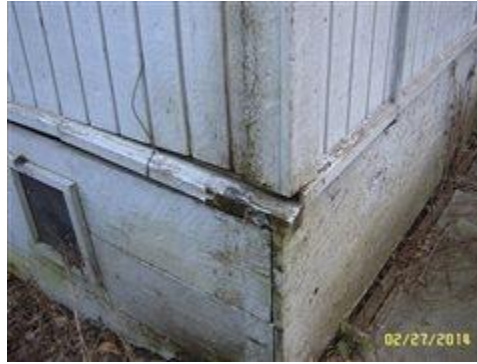
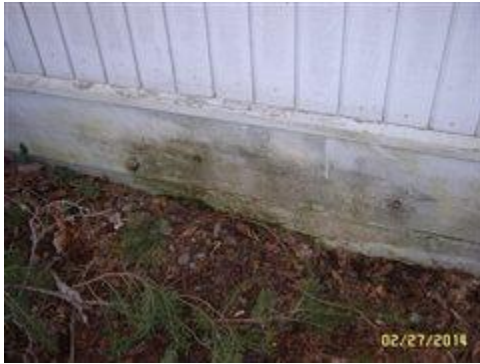
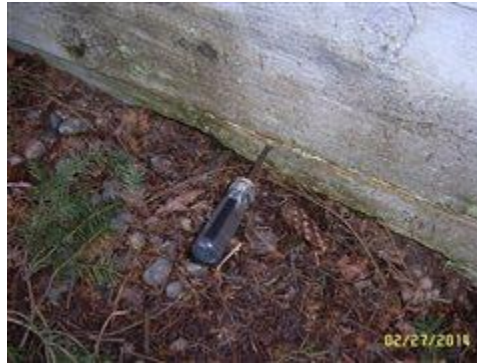
25) 🛠️ Extensions such as splash blocks or drain pipes for one or more downspouts were misaligned or missing. Water can accumulate around the building foundation or inside crawl

spaces or basements as a result. Recommend that a qualified person install, replace or repair extensions as necessary so rainwater drains away from the structure.

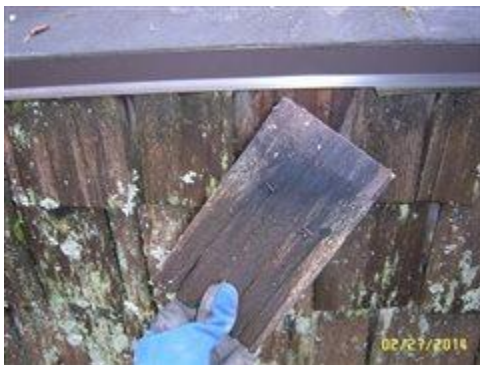
Photo 26-1

Many wood shakes or shingles were deteriorated. Leaks can occur as a result. This is a conducive condition for wood-destroying organisms. Recommend that a qualified contractor repair as necessary. For example, by replacing or fastening shakes or shingles, or installing flashing.

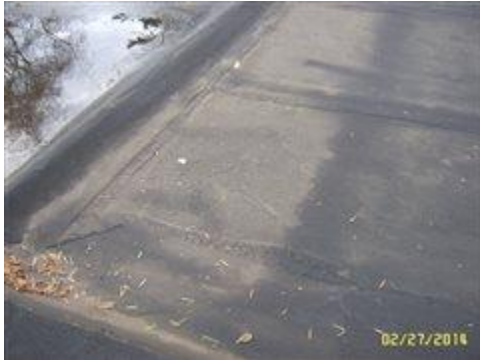
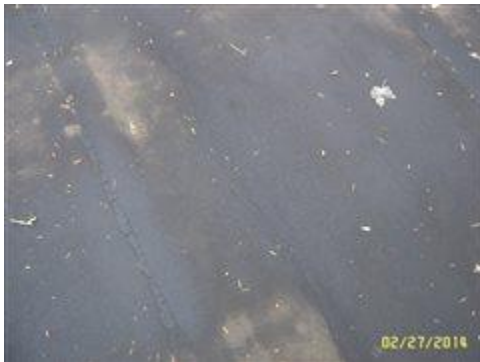
Alligatoring, crazing, fissures and/or cracks were found in one or more areas of the flat or low-slope roof surface. This is often caused by exposure to ultraviolet light (the sun), and eventually results in water penetrating the underlying roof membrane and causing leaks. This is a conducive condition for wood-destroying organisms. Recommend that a qualified contractor evaluate and repair as necessary.

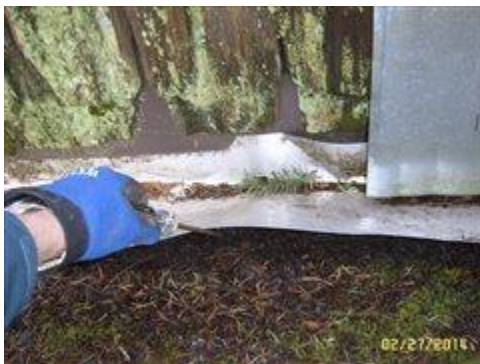
Photo 28-1

One or more roof flashings were substandard, loose. Leaks can occur as a result. This is a conducive condition for wood-destroying organisms. Recommend that a qualified person repair as necessary.

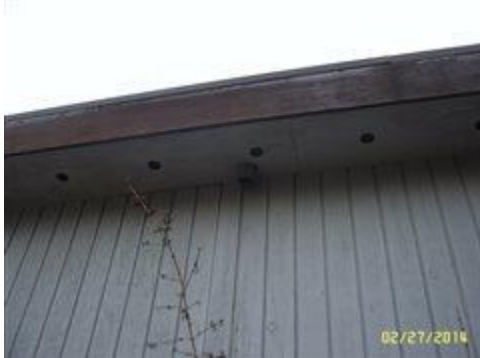
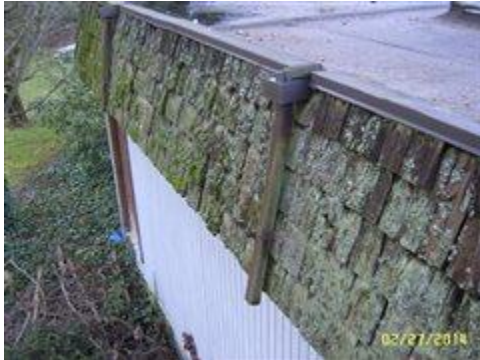
29) 🛠️ One or more downspouts were missing. Rainwater can come in contact with the building exterior or accumulate around the building foundation as a result. This is a conducive condition for wood-destroying organisms. Recommend that a qualified person repair as necessary.

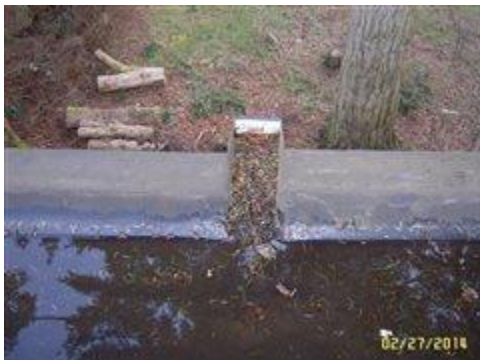
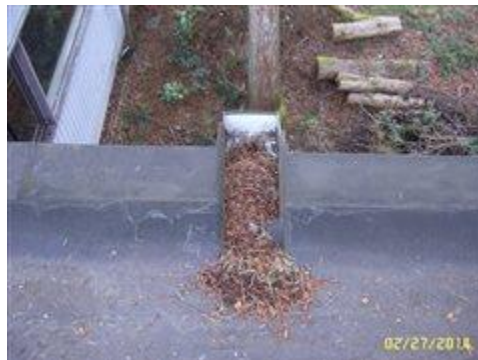
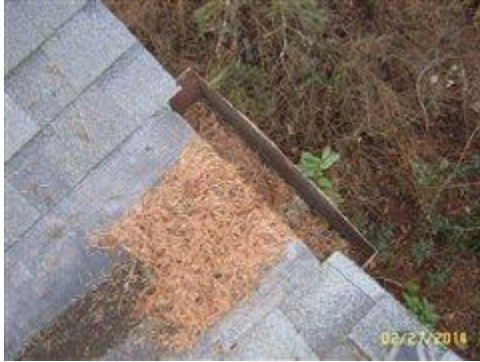
30) 🗑️ Significant amounts of debris have accumulated in one or more gutters or downspouts. Gutters can overflow and cause water to come in contact with the building exterior, or water can accumulate around the foundation. This is a conducive condition for wood-destroying organisms. Recommend cleaning gutters and downspouts now and as necessary in the future.

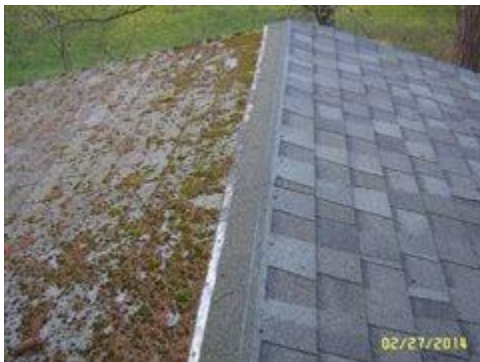
Photo 31-1

Moss was growing on the roof. As a result, shingles can lift or be damaged. Leaks can result and/or the roof surface can fail prematurely. Efforts should be made to kill the moss during its growing season (wet months). Typically, zinc or phosphate-based chemicals are used for this and must be applied periodically. For information on various moss treatment products and their pros and cons, visit:

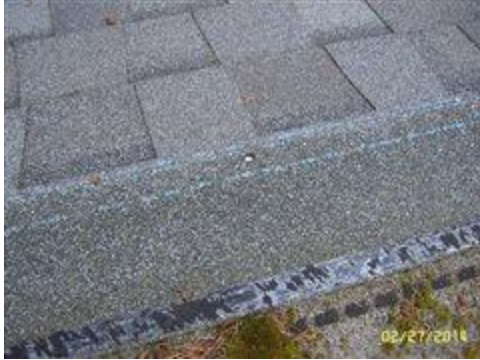
Photo 32-1

Nail heads were exposed at one or more shingles, mostly along ridges. More than just a few exposed nail heads may indicate a substandard roof installation. Recommend applying an approved sealant over exposed nail heads now and as necessary in the future to prevent leaks.

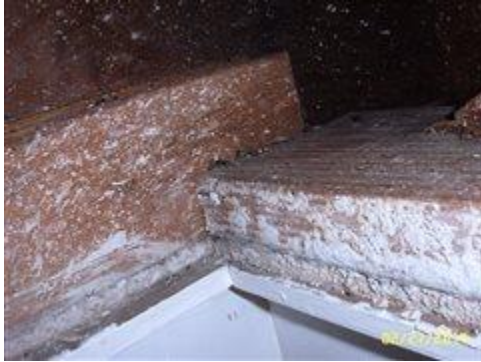
Photo 34-1

One or more attic access hatches or doors had no weatherstripping, or the weatherstripping was substandard. Weatherstripping should be installed around hatches or doors as necessary to prevent heated interior air from entering the attic. For more information, visit: <http://www.reporthost.com/?ATTACC>

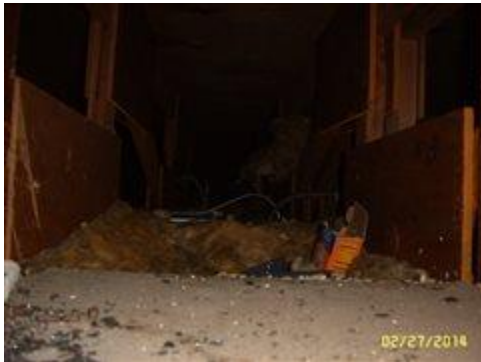
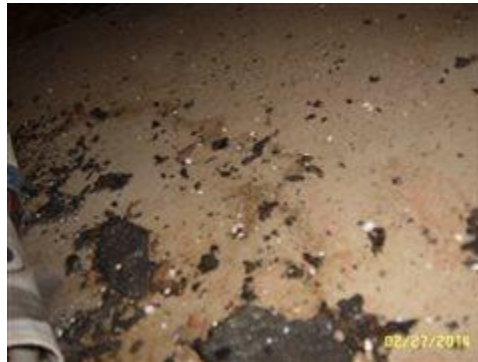
Insulation in the attic was damaged, apparently by rodents (e.g. burrow holes, feces, urine stains). If this report doesn't already recommend replacement of insulation for energy efficiency, the client may want to have insulation replaced for sanitary reasons or to prevent odors.

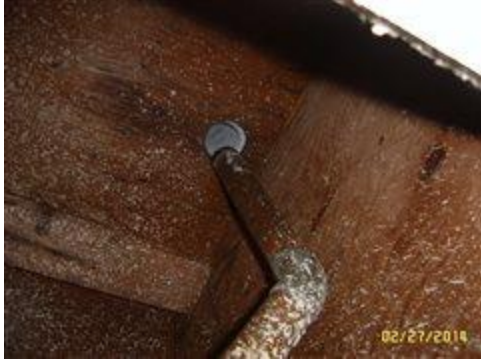
Photo 36-1

36) One or more plumbing vents were not properly connected to vent through the room and is venting into the attic. Recommend a qualified person evaluate and repair.

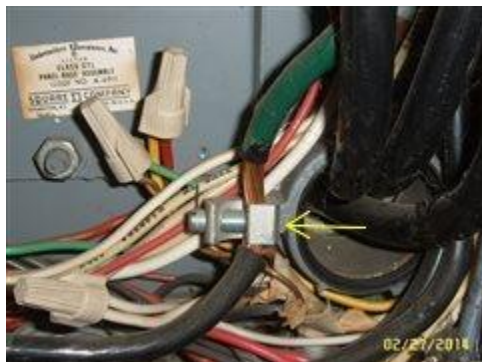
Photo 38-1

Modifications were made to panel(s) #A or to equipment inside. Electric panels and equipment inside are Underwriter Laboratory rated devices, and modifications to them are not allowed. Recommend that a qualified electrician evaluate and replace components or make repairs as necessary.

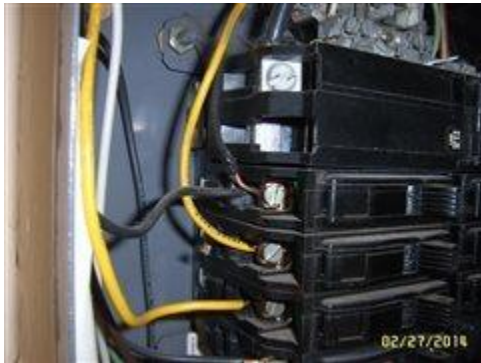
Photo 39-1

One or more circuit breakers in panel(s) #B were "double tapped," where two or more wires were installed in the breaker's lug. Most breakers are designed for only one wire to be connected. This is a safety hazard since the lug bolt can tighten securely against one wire but leave other(s) loose. Arcing, sparks and fires can result. Recommend that a qualified electrician repair as necessary. For more information, visit: <http://www.reporthost.com/?DBLTAP>

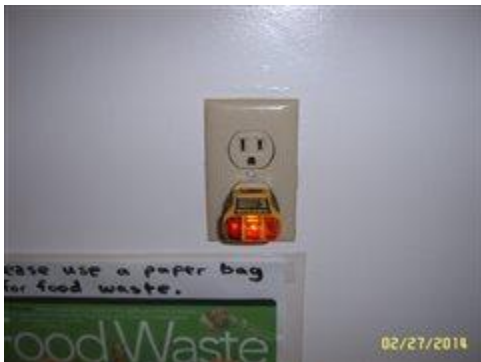
Photo 40-1

One or more electric receptacles (outlets) had reverse-polarity wiring, where the hot and neutral wires were reversed. This is a shock hazard. Recommend that a qualified electrician repair as necessary. For more information, visit: <http://www.reporthost.com/?RPR>

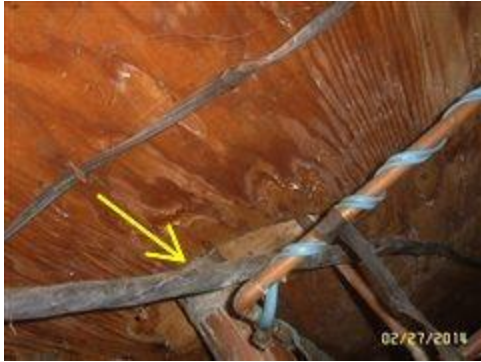
Photo 41-1

Main power feed traverses the crawlspace unprotected rather than in conduit. Recommend a qualified electrician evaluate and repair as necessary.

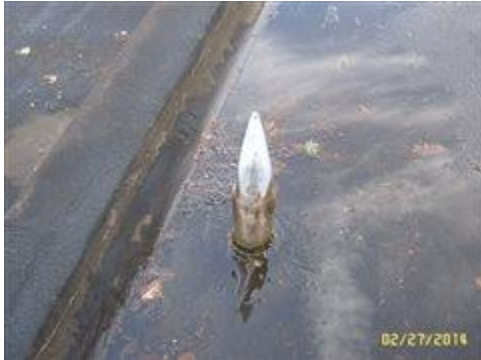
Photo 45-1

45) 🚧 One or more plumbing vent pipes were pinched closed at their ends. Sewer gases cannot escape and can enter living spaces as a result. Vent should be open so all vent pipes are unobstructed.

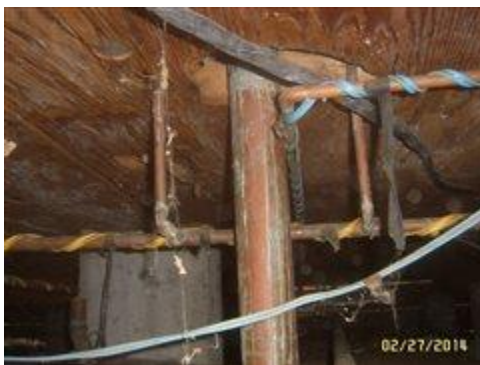
Photo 47-1

47) Exposed water supply lines were observed in the unconditioned crawlspace. Though many of them are wrapped in heat tape, they can be susceptible to freezing. Recommend a qualified plumber evaluate and repair as needed.

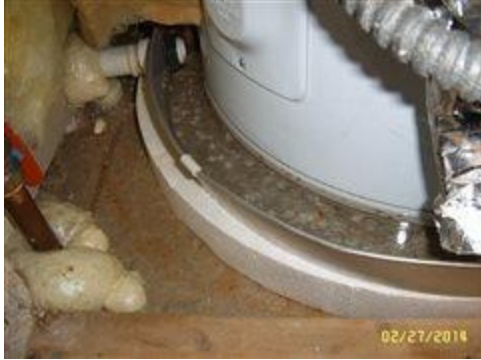
The water heater tank appeared to be leaking. This is an indication that the water heater has failed and is at the end of its service life. A qualified plumber should replace the water heater.

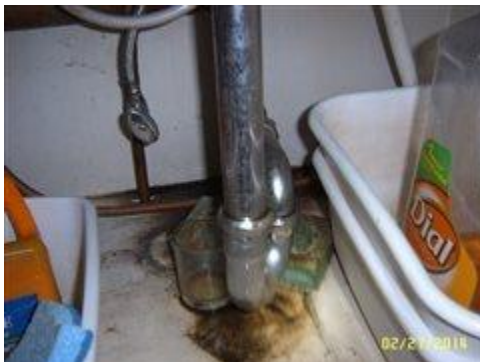
Photo 52-1

52) 🛠️ One or more sink drains were leaking. A qualified plumber should repair as necessary.

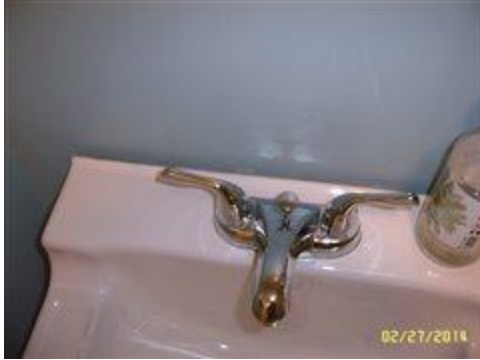
Photo 53-1

Gaps, no caulk, or substandard caulking were found between counter tops and back splashes. Water can penetrate these areas and cause damage. Recommend that a qualified person repair as necessary. For example, by installing or replacing caulk.

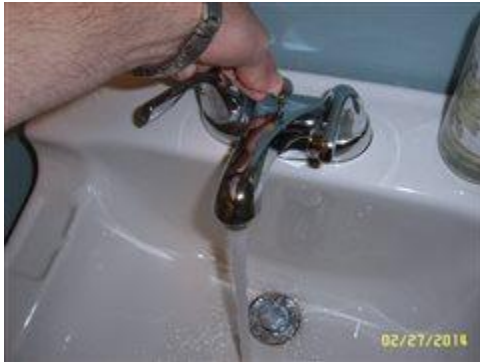
Photo 54-1

The sink drain stopper mechanism was inoperable. Recommend that a qualified person repair or replace as necessary.

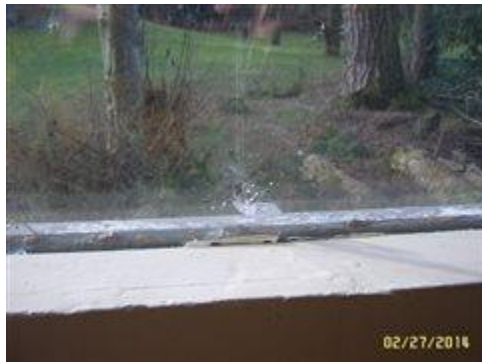
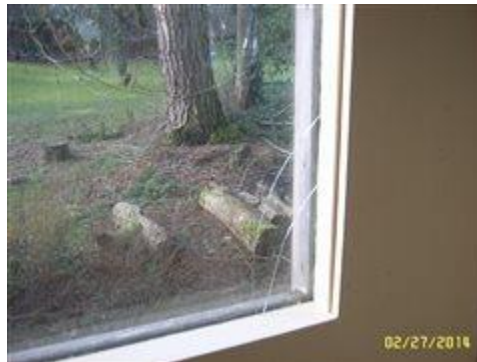
Glass in one or more windows was cracked, broken and/or missing. Recommend that a qualified contractor replace glass where necessary.

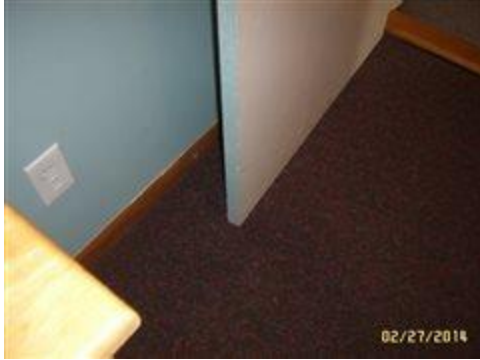
Photo 56-1

56) One or more interior doors drag on the carpet as they open. Recommend a qualified person evaluate and repair as necessary.
