Mountains to Sound Home Inspection

Building Inspection Report

Client(s): Cal Spangler
Property address: **Shoreline Unitarian Universalist Church**
14724 1st Ave NE
Shoreline WA 98155-6806

Inspection date: Thursday, February 27, 2014

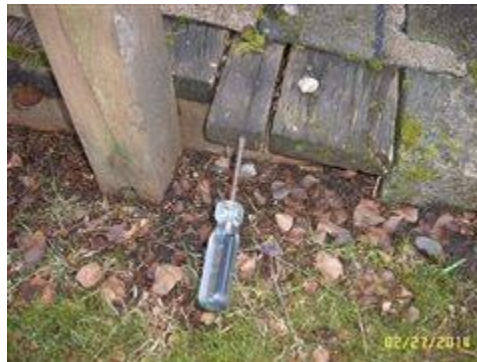
Photo 4-2

- 4) 🔍 Fungal rot was found in decking boards at one or more decks or porches. Conductive conditions for this such as wood-soil contact should be corrected. Recommend that a qualified contractor evaluate and repair as necessary. All rotten wood should be replaced.

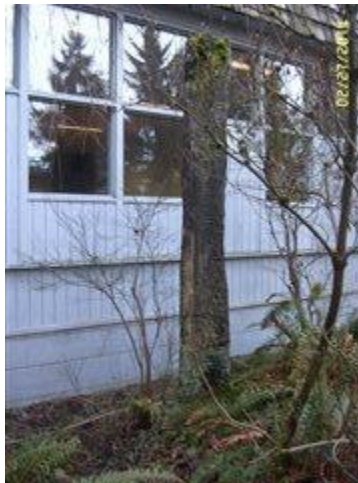
Photo 9-2

One or more large tree stumps were close to the building exterior. Wood-destroying insects such as carpenter ants nest in such stumps and are more likely to infest the building as a result. Recommend that large tree stumps within a few feet of the building be removed by a qualified tree service contractor.

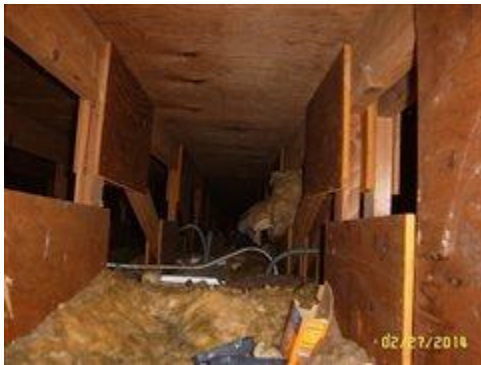
Photo 37-1

37) Attic, for your information.

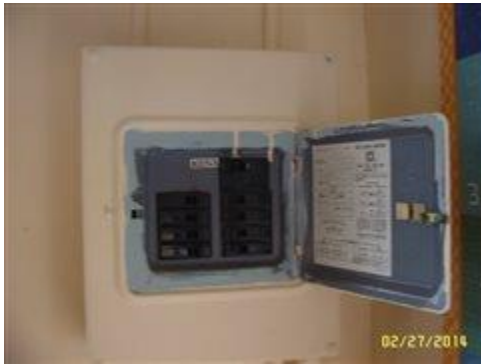
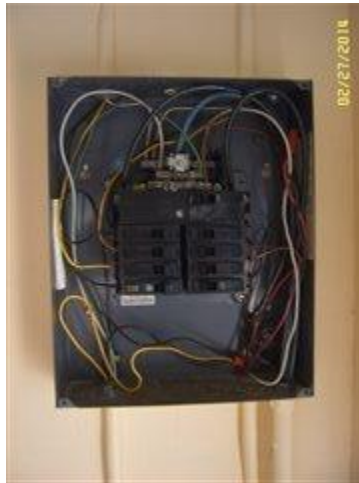
43) Sub Panel, for your information.

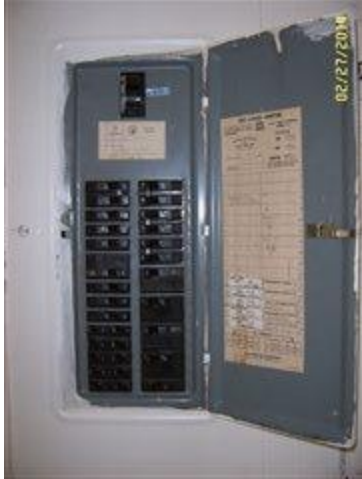
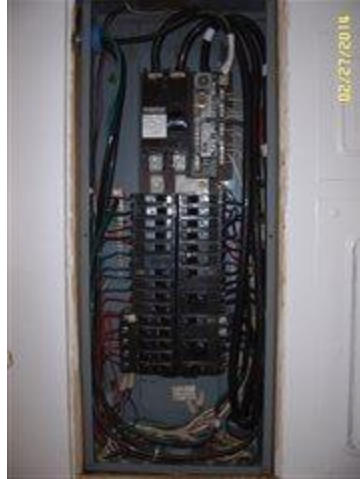
44) Main electrical panel, your your information.

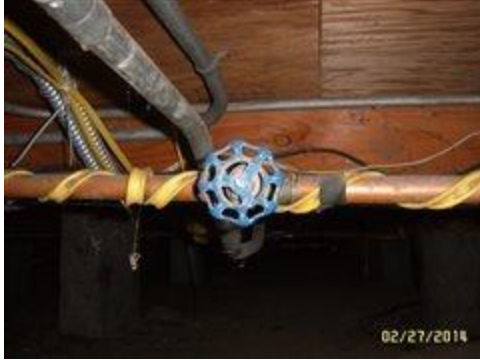
Photo 48-1

46) ⓘ What appeared to be the main water shut-off valve was located in the crawl space. This is an inconvenient location at best, and may prevent the water from being turned off in a timely manner in the event of a plumbing emergency. Consider having a qualified plumber relocate the shut-off valve to a more convenient location, such as in a closet or a cabinet under a sink.

48) Main water shutoff located in crawl space, for your information.

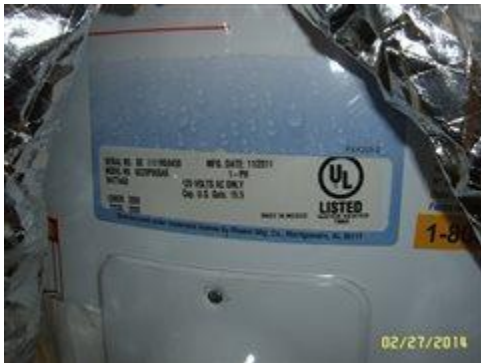
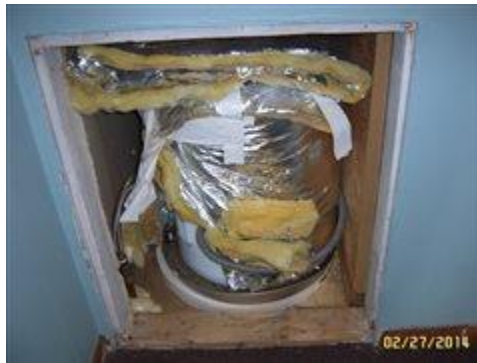
51) Water heater, for your information.
